# 2014 Water Infrastructure Report

Published: 02/20/2015

Municipal Services Department

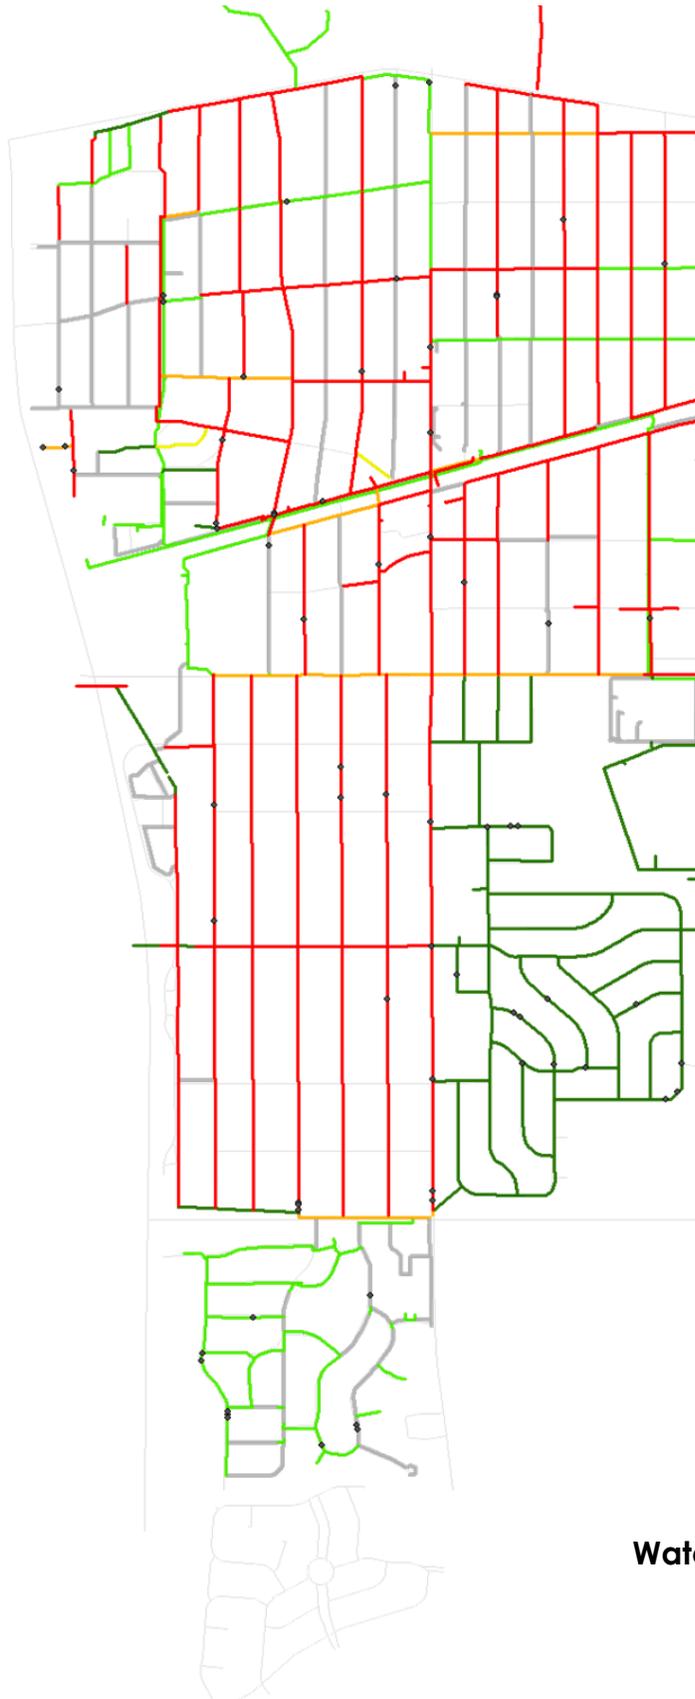
# Village Infrastructure Grouped by Age

Water Main Pipe Age Distribution by 10 Year Increments

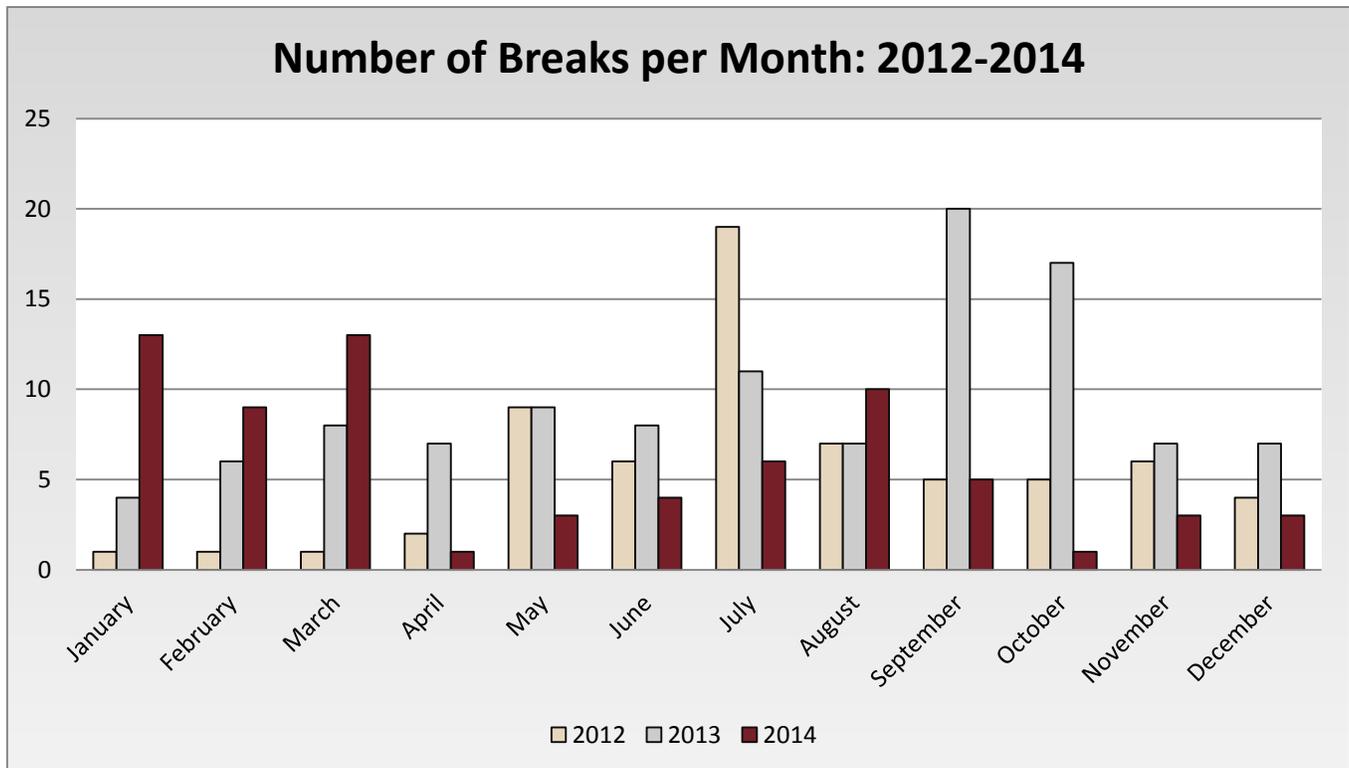
Village staff continues to track breaks throughout the distribution system to help identify future capital improvement projects in those areas that show increased frequency or clusters of occurrences. To the right is a table comparing the last three years of data through each month of the year. Below is a table showing the break trends for the past three years. 2014 showed indications that the number of breaks was beginning to taper off. January of 2014 was an active year as was the summer demand period, but both the spring and fall of 2014 showed decreasing numbers of incidents compared to previous years.

Over the past several years the Village has experienced an increase in the number of water main breaks throughout the distribution system. The [2012](#) and [2013](#) water main break reports looked at these break trends in extensive detail and concluded that the breaks were likely a result of the age of the pipes in the distribution system and the change in the water chemistry as a result of the new water treatment facility.

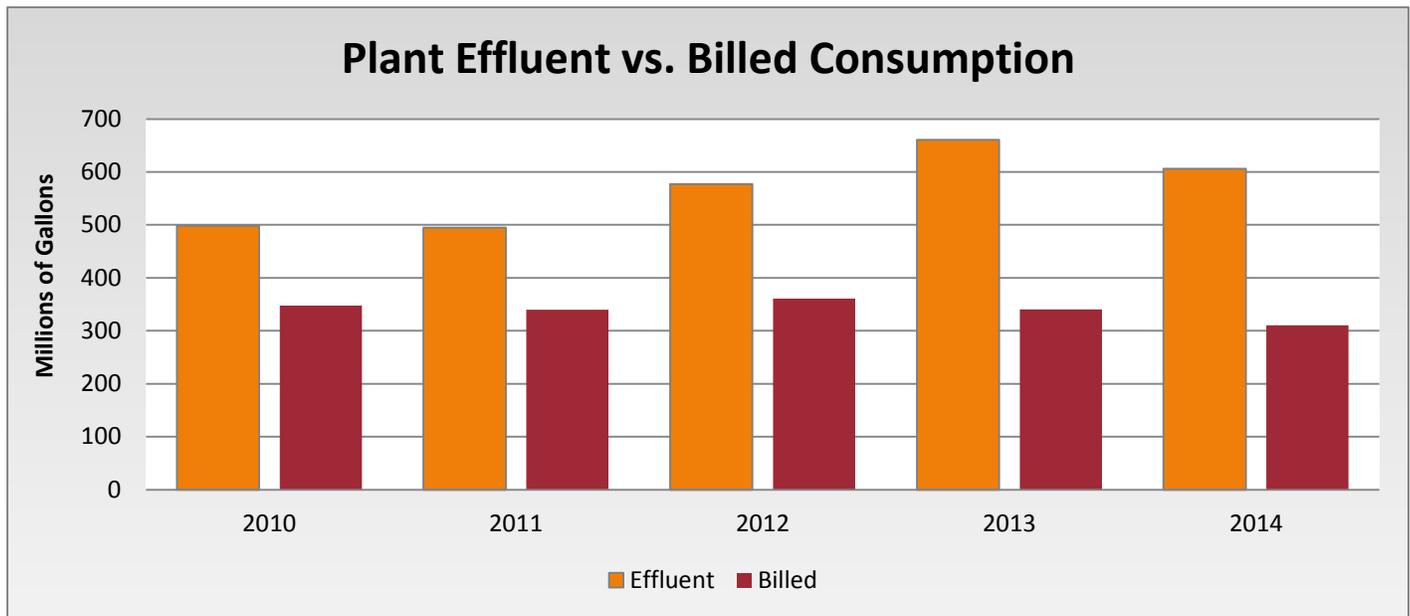
The concerning trend in this graph is the trending increase in the amount of water output from the water treatment plant and the trending decrease from the billed water recorded for consumption. At this point the Village does not have a definitive answer to these trends. One possible factor could be the age of the residential meters located in most homes. The last major change in resident meters occurred in 1994, which would put the age of the residential meters at over twenty years. The old Sensus meters utilize an impeller that rotates with the flow of water to record the volume. Those moving parts may degrade over time and low flows through the meters may not be recorded. A decrease in accuracy of merely 5% of the flow through the residential meters in town could account for nearly 30 million gallons annually.

The Village annually tracks the amount of water that is produced from the water treatment plant and the amount of water that is billed to residents. Due to a variety of factors including water main repairs, the age of the meters in resident's homes, unmetered usage and small leaks in the distribution system, a percentage of water that is pumped to distribution is never billed or accounted for.
