2013 Water Main Break Report

MUNICIPAL SERVICES DEPARTMENT

Published: 03/07/2014

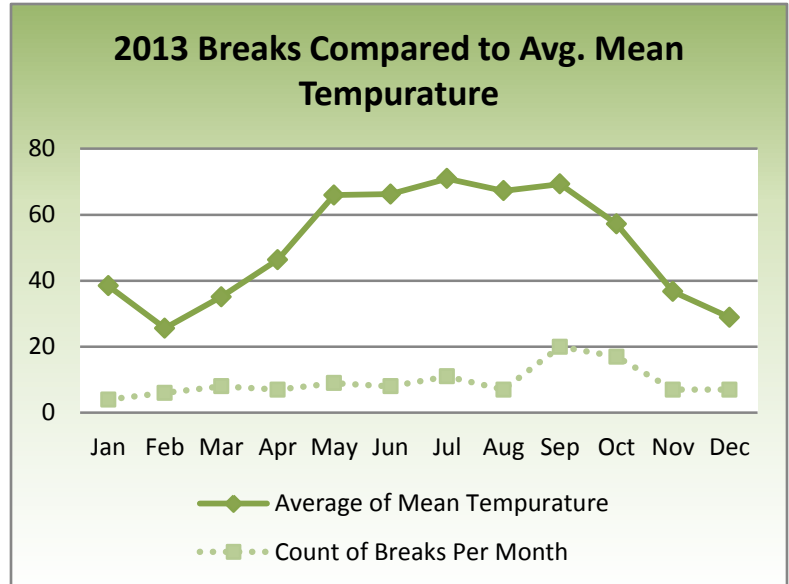
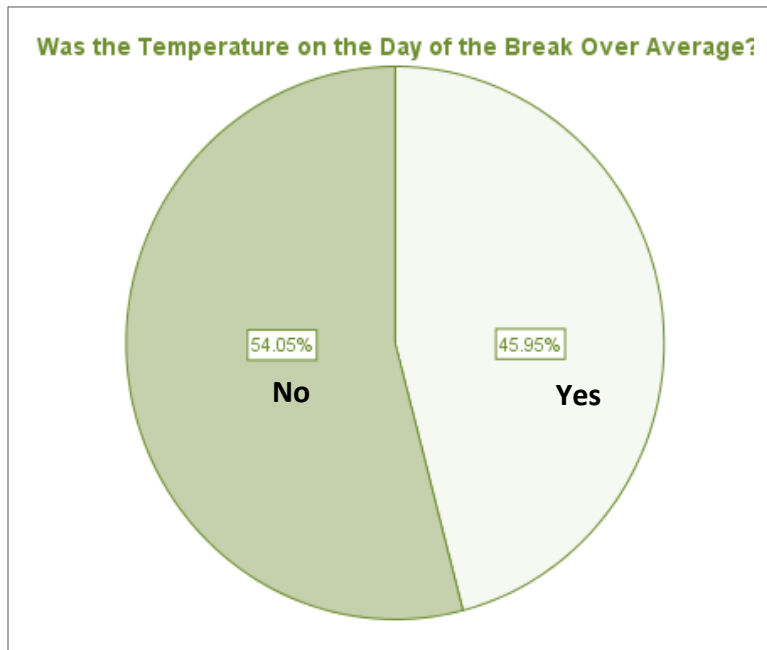
The 2013 summer season demonstrated much milder and more even temperatures throughout the system's high demand periods and the additional data allowed Village staff to compare the main break trend data against additional temperature information. The data for 2013 showed that the number of main breaks per month remained fairly consistent through most of 2013, even when temperatures rose.

The chart to the left is a portion of the same analysis done on the 2013 water main breaks. The data indicates that the 2013 water main breaks show no direct relationship to higher than average temperatures.

Similarly to the rainfall analysis, staff explored the possibility that there could be a correlation between the higher than average summer temperatures and the increased number of water main breaks in 2012. Using SPSS, staff performed a t-test analysis. The p-value for this relationship was much greater than 0.05 which concluded that there was no significant relationship present.

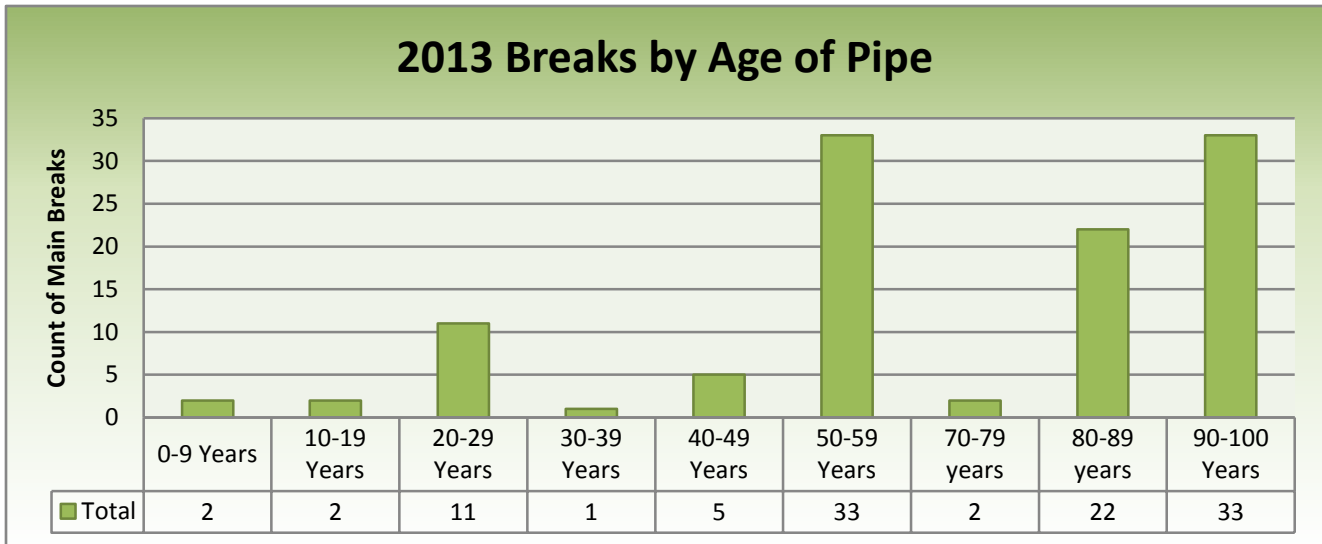
Using the information in the Village's Geographic Information System, staff was able to identify the age of each pipe that had a break occur on it. The distribution from the break data indicated that 55 of the 111 breaks that occurred in 2013 occurred on pipe that was eighty years old or older. There were also 33 breaks on pipe that was aged between 50-59 years in age. Of those 33 breaks, 12 of them occurred in the Ridgewood subdivision and 15 of them occurred in the Springdale subdivision with each grouping of breaks representing the mean age of the total pipe in each subdivision.

Old Town north represented the vast majority of breaks for pipe over 90 years in age with 21 of the 33 total breaks in that cluster.

The Village analyzed the age of the pipe for each break and compared it to the average life of ductile iron pipe at 50 years. Analysis in SPSS showed that there is in fact a significant relationship between the age of the pipe and the amount of water main breaks in 2013.
